Helpful Hints

SUBJECT: Optic Sensor Adjustment for 20 Plus Venders

MODELS: 20 Plus Venders

REASON FOR HELPFUL HINT: To properly adjust the optic sensor when replacing a control board in a 20 Plus Vender.

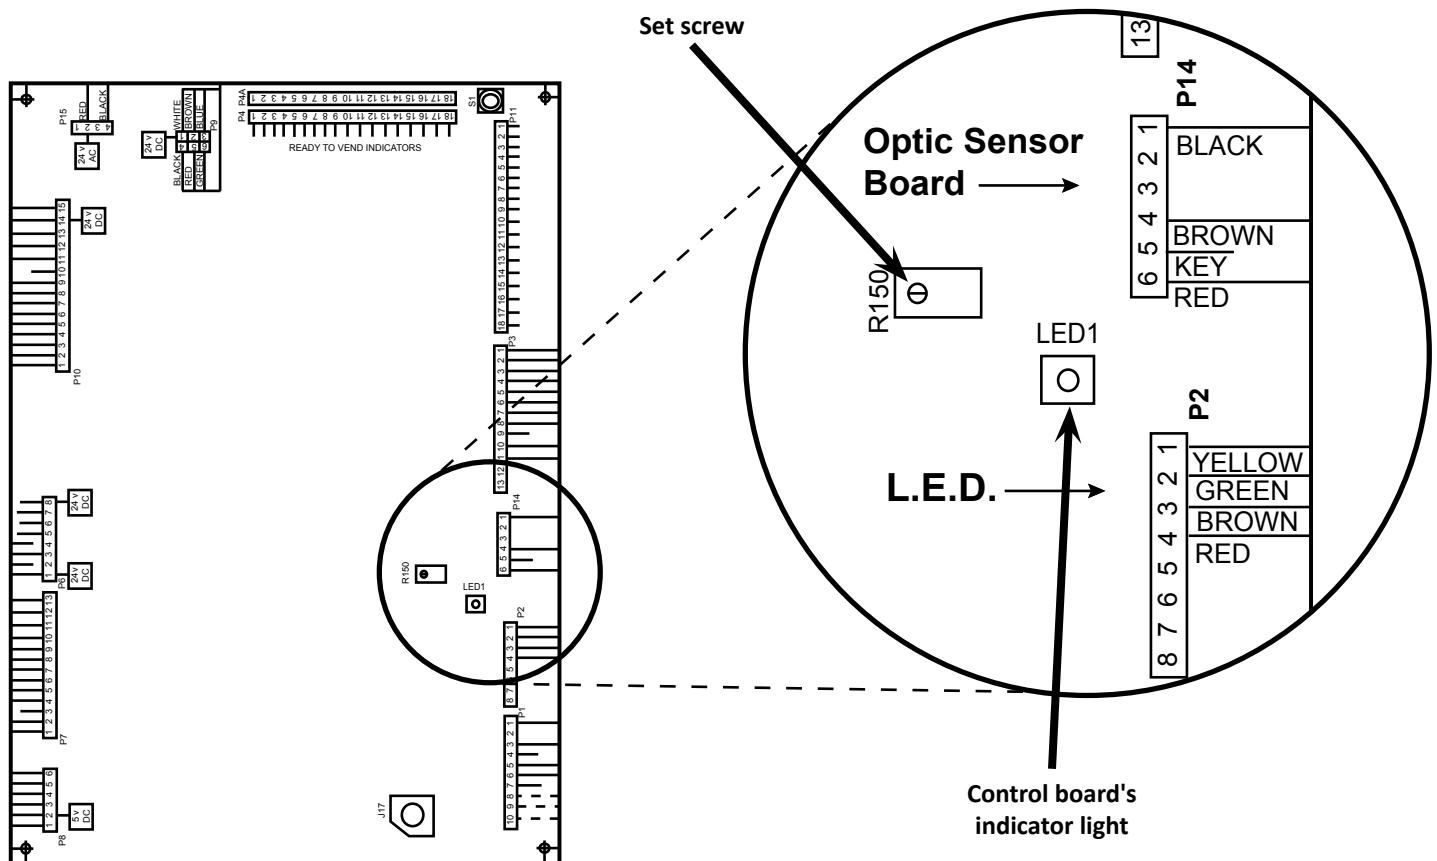
1. Unplug optic sensor harness from the control board (P14).
2. Adjust the set screw (on the control board) clockwise until the indicator light becomes solid. Once the light becomes solid, continue two full turns clockwise.
3. Plug optic sensor harness to the control board (P14).
Note: After the optic sensor harness is plugged in, the indicator light on the control board will go out and the indicator light on the optic sensor board will come on.
4. Test adjustment by passing your hand across the path of the two optical sensors in the cabinet. Watch for the indicator light on the control board (LED1) to blink when the path is broken.

CAUTION: If the optic sensor harness is plugged up to the wrong pin position (P2 which is for the LED), the optic sensor board will become inoperable.
