# SERVICE BULLETIN # 00169

**SUBJECT:** Acceptance problem with tokens or larger coins

**MODELS:** All GIII Venders with EVS-2 software (PO # 1478 to 1504)

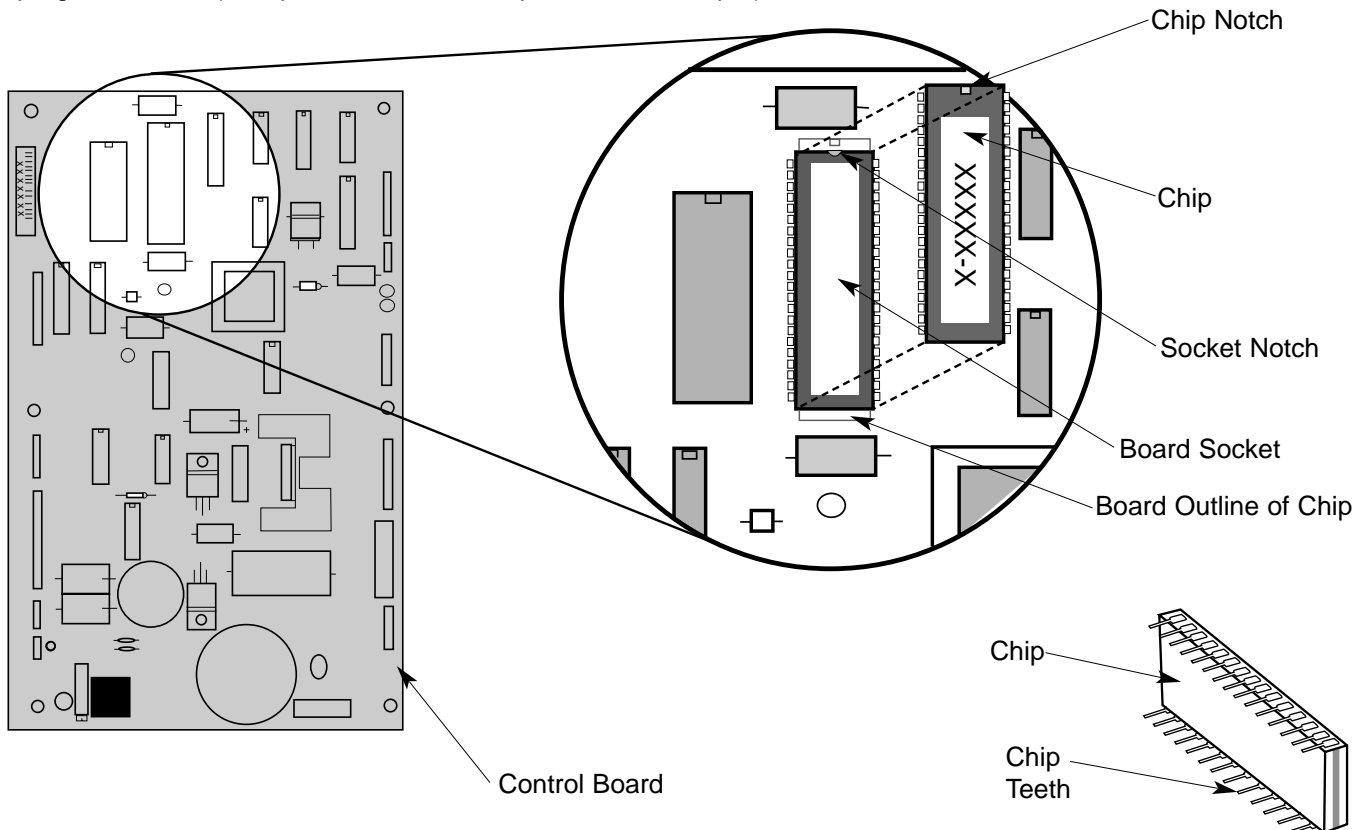
This applies to GIII venders with E.V.S. software which are demonstrating erratic acceptance of tokens or larger coin types (8-15). Changers have the ability to accept 16 different coin types 0-15 (0 being the smallest denomination and 15 being the largest denomination). If you have EVS 67121-2 chip or EVS 67122-2 and are having an acceptance problem with tokens or larger coin types; the above chips will solve this problem for all G-III venders with EVS software.

1. Remove power from vender by unplugging vender's main power cord from the AC voltage power source (wall outlet)
2. Using a chip extractor (or small screwdriver) remove 67121-X or 67122-X chip.
3. Position the new chip by aligning the chip notch with the socket notch of the control board.
4. Insert the right-side teeth of chip into the board socket, then push chip slightly to the right until the left-side teeth line up with the board socket, then push the chip into the board socket.
5. Make sure all chip teeth are inserted into the board socket.
6. Reprogram vender (i.e. space to sales, vend price, column depth).
