# SERVICE BULLETIN 286

**SUBJECT:** RVV 500 Refrigeration Issue

**MODELS:** RVV 500

## REFRIGERATION UNIT REPLACEMENT INSTRUCTIONS:

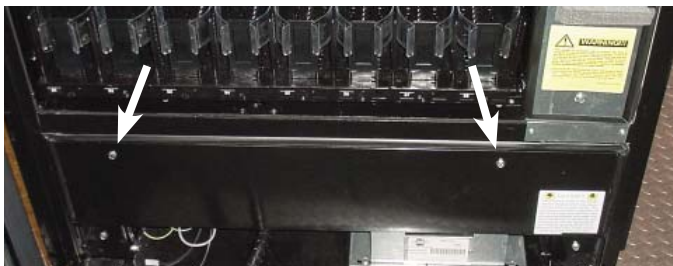
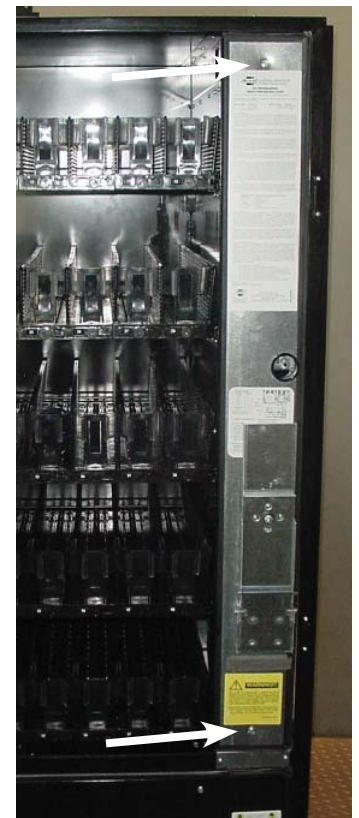
**Figure 1.**

*Refrigeration door and inner door assembly*

Use a 3/8" (10 mm) nutdriver to remove the screws which secure the refrigeration door and the inner door assembly, as indicated by the white arrows in these photographs.

1. Remove power from the vender by unplugging the vender's main power cord from the AC voltage source (wall outlet).
2. Remove the vender's refrigeration door and the inner door assembly. (See Figure 1.)

19. Reinstall the refrigeration door and inner door assembly that were removed in Step 2 above.
20. Restore power to the vender by plugging the vender's main power cord into the AC voltage source (wall outlet).

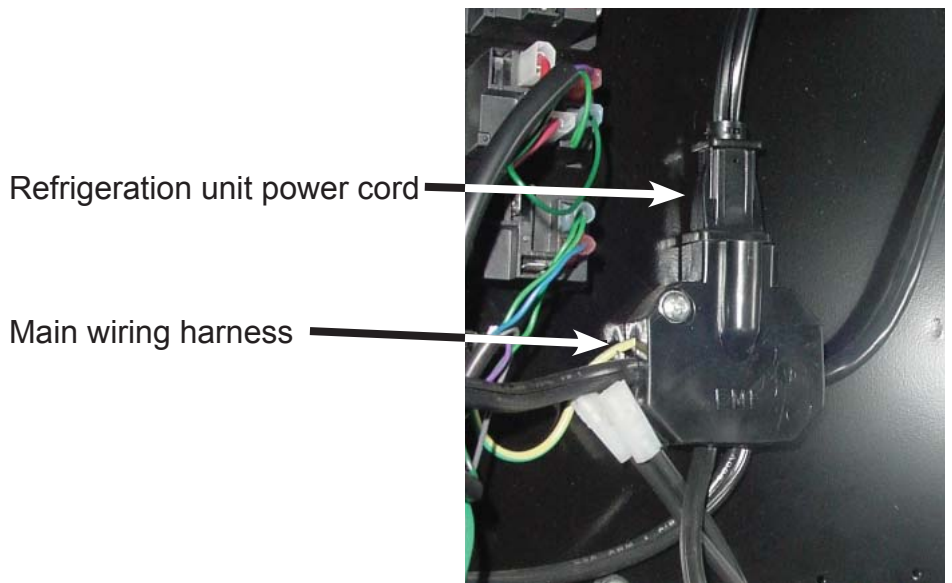
**Figure 2.**

Unplug the refrigeration unit power cord from the main wiring harness.

3. Unplug the refrigeration unit power cord from the main wiring harness. (See Figure 2.)
4. Remove the two bolts that secure the front of the refrigeration unit base plate. (See Figure 3.)

17. Reinstall the mullion plate that was removed in Step 5 above. Once the mullion plate is installed, reinstall the bottom inner door channel.
18. Plug the refrigeration unit power cord into the main wiring harness.

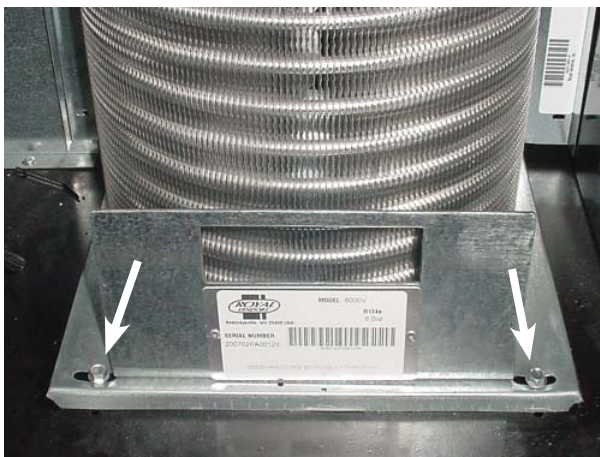
**Figure 3.**

Refrigeration base plate

Use a 3/8" (10 mm) nutdriver to remove the screws which secure the refrigeration unit base plate, as indicated by the white arrows in the photograph.

13. Reinstall the two bolts that were removed in Step 4 above.
14. Reinstall the two screws that were removed in Step 5 above.
15. Reinstall the evaporator cover that was removed in Step 7 above. Note the evaporator cover tab slots shown in Figure 7. The tabs on the evaporator cover must be inserted into these slots.

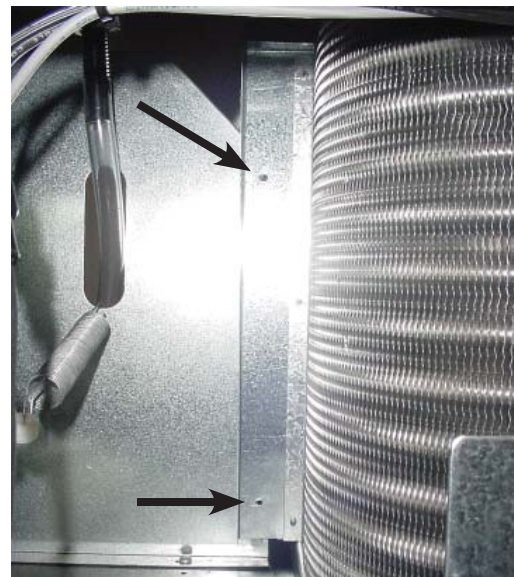
**Figure 4.** Refrigeration baffle

Use a Phillips screwdriver to remove the screws which secure the refrigeration baffle to the side of the unit, as indicated by the black arrows in the photograph.

5. Remove the two screws that secure the refrigeration baffle to the side of the unit. (See Figure 4.)
6. Remove the bottom inner door channel and the mullion plate. (See Figure 5.)

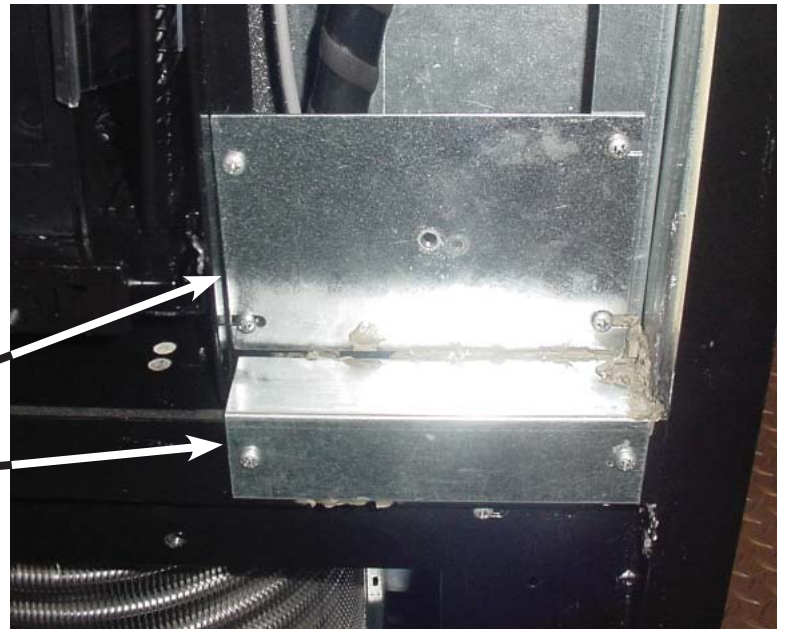
**Figure 5.**

*Bottom inner door channel and mullion plate*

Use a Phillips screwdriver to remove the screws which secure the bottom inner door channel and the mullion plate.

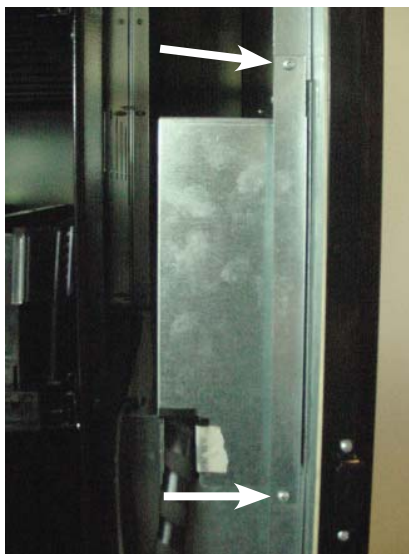
**Figure 6.** *Evaporator cover*

Use a Phillips screwdriver to remove the screws which secure the evaporator cover, as indicated by the white arrows.

7. Remove the evaporator cover. (See Figure 6.)
8. Remove the bolt and the screw that secure the evaporator. (See Figure 7.)
9. Remove the Permagem® that surrounds the refrigeration tubing. (See Figure 8.)

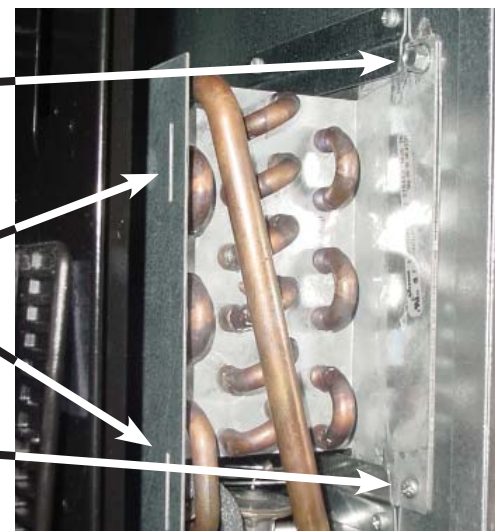
**Figure 7.** *Evaporator*

Use a 3/8" (10 mm) nutdriver to remove the bolt that secures the evaporator. Use a Phillips screwdriver to remove the screw that secures the evaporator. (Note the evaporator cover tab slots in this photograph.)

12. Reinstall the bolt and the screw that were removed in Step 8 above.

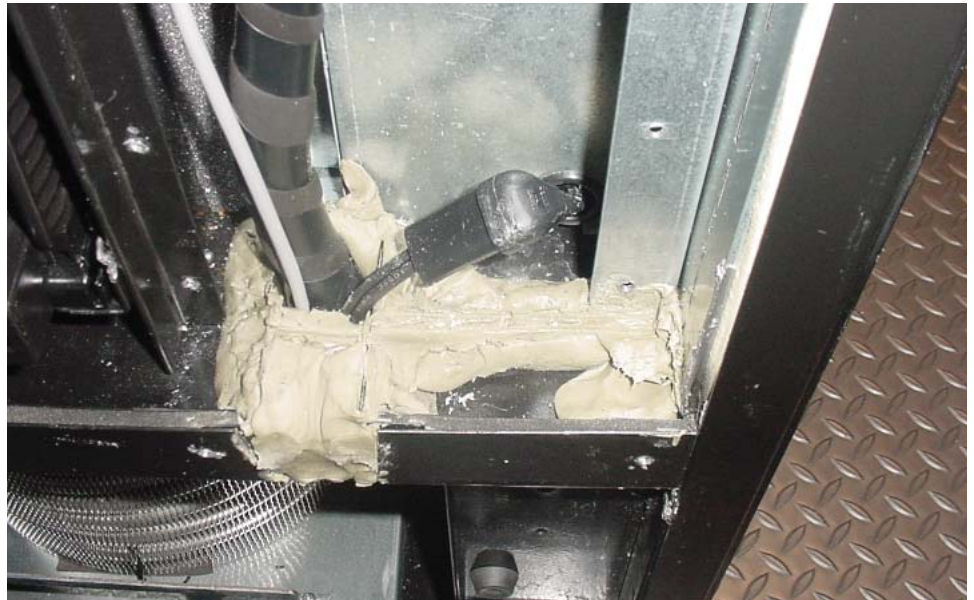
**Figure 8.**

*Permagum®*

When resealing this area with Permagum®, ensure that it is installed thoroughly so no air will be allowed to leak into the evaporator area.

16. Reseal the mullion area with Permagem®. Ensure that the Permagem® is installed thoroughly so no air will be allowed to leak into the evaporator section on the mullion plate has been reinstalled. The picture in Figure 8 shows the Permagem® correctly installed in this area.

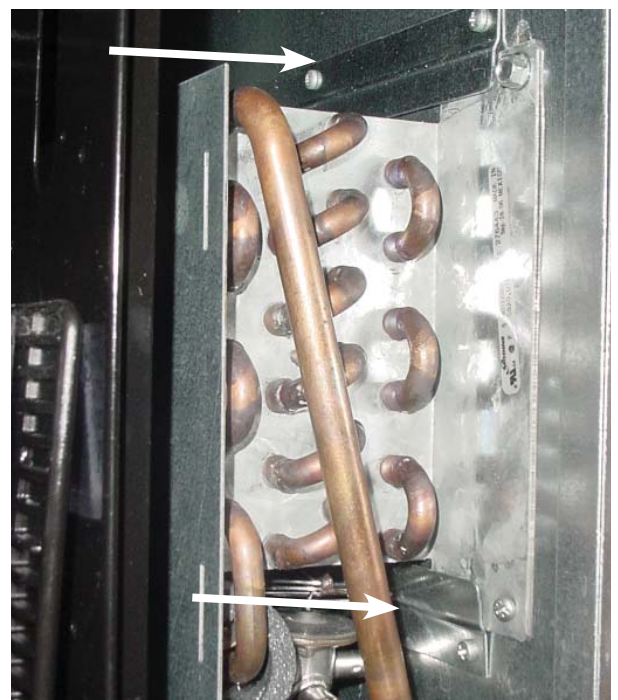
**Figure 9.**

*Evaporator slides*

Ensure that the evaporator slides securely into the rails mounted on the side wall of the evaporator section, as indicated by the white arrows.

11. Install the new refrigeration unit in the vender. When installing the unit, ensure that the evaporator slides securely into the rails mounted on the side wall of the evaporator section. (See Figure 9.)
