# Helpful Hints 0011

**SUBJECT:** Replacing a Vend Motor (MIV)

**MODELS:** Merlin IV

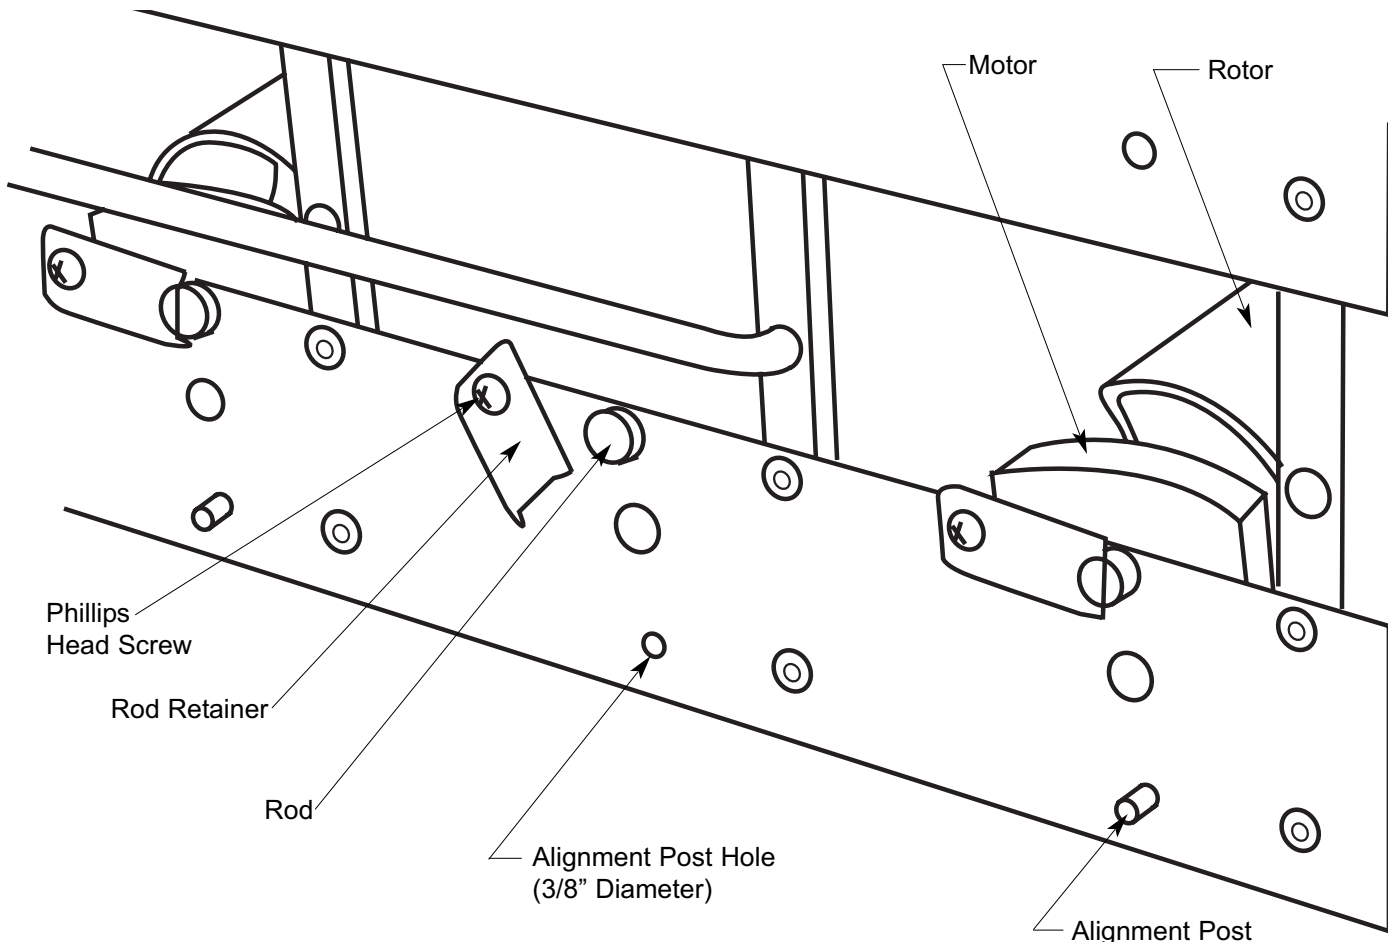
- Notes:**
- 1) The newer vend motor (839031) has a black casing; the older vend motor (839029) has a white casing.
  - 2) Once the alignment hole has been enlarged, only the newer vend motor with the black casing can be used.

1. Power Down Vender
2. Empty product out of the front and rear column
3. Loosen rod retainer with a Phillips head screwdriver
4. Unplug motor
5. Pull rod out
6. Take out rotor by pushing up on the rear of the rotor to force the front of the rotor to drop out.
7. If the motor that is going to be installed has a white casing (839029), follow steps 8-11. If the motor to be installed has a black casing (839031), the alignment post hole will need to be enlarged with a 3/8" drill bit. *See illustration below for location.*
8. Install the new vend motor with rotor, then insert the rod.
9. Connect wiring to vend motor
10. Tighten rod retainer
11. Test vend to ensure proper vending
